New Hampshire Volunteer Lake Assessment Program

2002 Bi-Annual Report for Baxter Lake Farmington

NHDES Water Division Watershed Management Bureau 6 Hazen Drive Concord, NH 03301

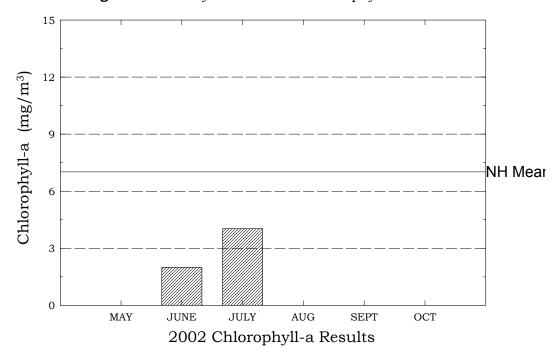
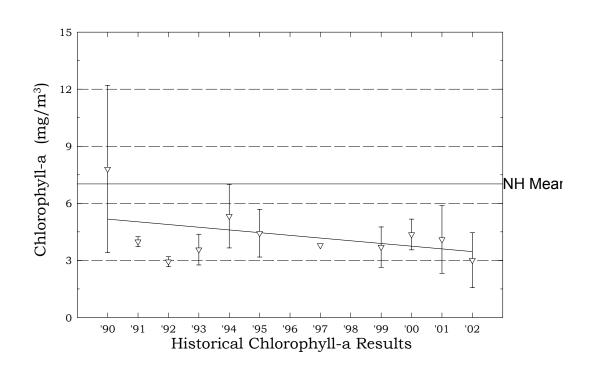
Figure 1. Monthly and Historical Chlorophyll-a Results

Figure 1 and Table 1: The graphs in Figure 1 (Appendix A) show the historical and current year chlorophyll-a concentration in the water column. Table 1 (Appendix B) lists the maximum, minimum, and mean concentration for each sampling season that the lake/pond has been monitored through the program.

The current year data (the top graph) show that the chlorophyll-a concentration *increased* from June to July. Unfortunately, due to a laboratory equipment malfunction, the chlorophyll data for the August sampling event was not available. We apologize for this problem and loss of data.

The historical data (the bottom graph) show that the 2002 chlorophyll-a mean is *less than* the state mean.

Overall, visual inspection of the historical data trend line (the bottom graph) shows *a relatively stable* in-lake chlorophyll-a trend. Specifically, the chlorophyll-a concentration has remained *approximately the same*, and has been *less than* the state mean, since monitoring began. Unfortunately, the historic data could not be statistically analyzed this season since the lake was not sampled in 1996. After 10 consecutive years of sample collection, we will be able to conduct a statistical analysis of the historic data to objectively determine if there has been a significant change in the annual mean chlorophyll-a concentration.

While algae is naturally present in all lakes/ponds, an excessive or increasing amount of any type is not welcomed. In freshwater lakes/ponds, phosphorus is the nutrient that algae depend upon for growth. Therefore, algal concentrations may increase when there is an increase in nonpoint sources of nutrient loading from the watershed, or in-lake sources of phosphorus loading (such as phosphorus releases from the sediments). It is important to continually educate residents about how activities within the watershed can affect phosphorus loading and lake quality.

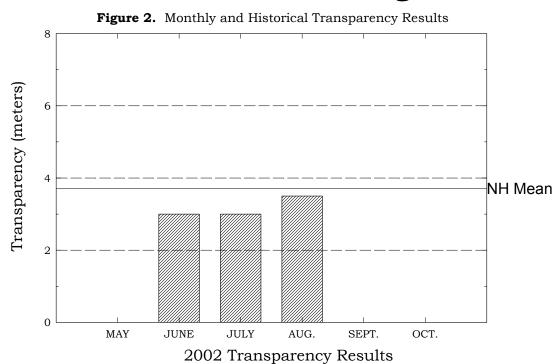
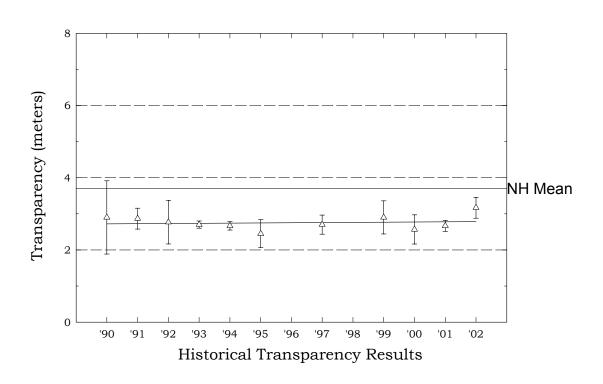
Figure 2 and Table 3: The graphs in Figure 2 (Appendix A) show historical and current year data for lake/pond transparency. Table 3 lists the maximum, minimum and mean transparency data for each sampling season that the lake/pond has been monitored through the program.

The current year data (the top graph) show that the in-lake transparency **remained stable** from June to July, and then **increased slightly** from July to August. On the July sampling event the secchi disk was visible on the bottom, which indicated that the water level was lower in July than in August.

The historical data (the bottom graph) show that the 2002 mean transparency is *slightly less than* the state mean.

Overall, visual inspection of the historical data trend line (the bottom graph) shows **a stable** trend for in-lake transparency. Specifically, this means that the transparency has **remained stable**, **and approximately one meter less than** the state mean, since monitoring began.

Typically, high intensity rainfall causes erosion of sediments into lakes/ponds and streams, thus decreasing clarity. Efforts should continually be made to stabilize stream banks, lake/pond shorelines, disturbed soils within the watershed, and especially dirt roads located immediately adjacent to the edge of tributaries and the lake/pond. Guides to Best Management Practices designed to reduce, and possibly even eliminate, nonpoint source pollutants, such as sediment loading, are available from NHDES upon request.

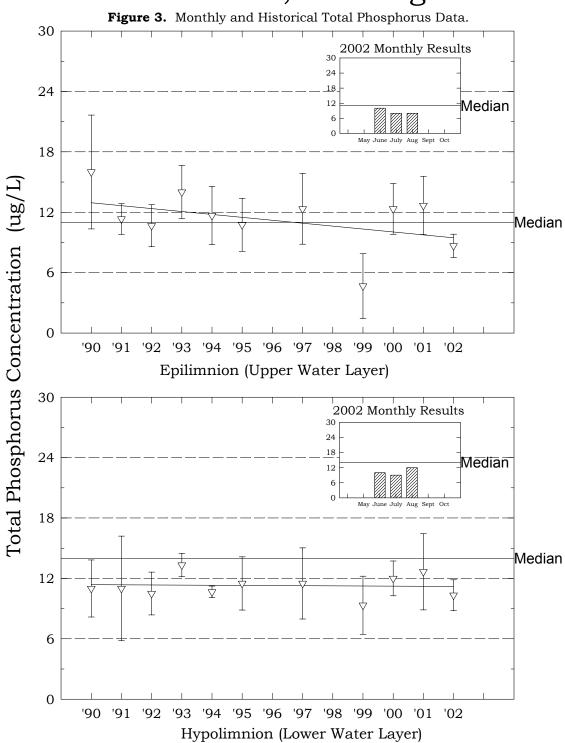
Figure 3 and Table 8: The graphs in Figure 3 (Appendix A) show the amounts of phosphorus in the epilimnion (the upper layer) and the hypolimnion (the lower layer); the inset graphs show current year data. Table 8 (Appendix B) lists the annual maximum, minimum, and median concentration for each deep spot layer and each tributary since the lake/pond has joined the program.

The current year data for the epilimnion (the top inset graph) show that the total phosphorus concentration **decreased slightly** from June to July, and then **remained stable** from July to August.

The historical data show that the 2002 mean epiliminetic total phosphorus concentration was **slightly less than** the state mean.

The current year data for the hypolimnion (the bottom inset graph) show that the total phosphorus concentration **remained approximately stable** from June to July, and then **increased slightly** from July to August.

The historical data show that the 2002 mean hypolimnetic total phosphorus concentration was *less than* the state mean.

Overall, visual inspection of the historical data trend line for the epilimnion show **a variable** total phosphorus trend, which means that the concentration has **fluctuated** in the epilimnion since monitoring began.

Overall, visual inspection of the historical data trend line for the hypolimnion shows **a** stable total phosphorus trend. Specifically, this means that the concentration in the hypolimnion has **remained** approximately the same, and has been slightly less than the state median, since monitoring began. We hope this trend continues!

One of the most important approaches to reducing phosphorus loading to a waterbody is to continually educate watershed residents about its sources and how excessive amounts can adversely impact the ecology and value of lakes and ponds. Phosphorus sources within a lake or pond's watershed typically include septic systems, animal waste, lawn fertilizer, road and construction erosion, and natural wetlands. If you would like to educate watershed residents about how they can help to reduce phosphorus loading into the lake/pond, please contact the VLAP Coordinator.
